**Flood Control Project Maintenance
Levee Inspections**

Maintenance Issue Types Only, Levee Inspection Report By Mile - Fall 2018

Sacramento Maintenance Yard Putah Creek

Waterway	Bank	Unit Miles	Inspection Start/End	Inspector
Unit No. 01 Putah Creek or North Levee	Left	8.79	09/27/2018 09/27/2018	David Julian

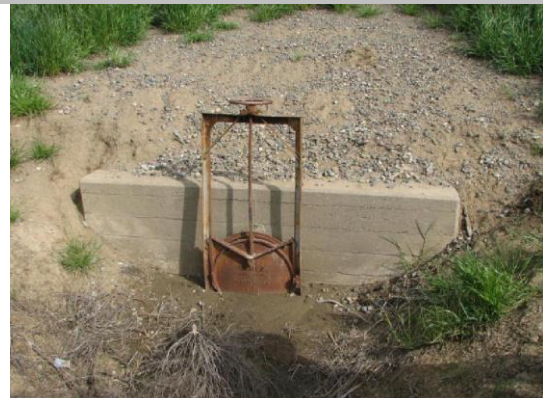
Photo 1 of 3 : UCIP_FA_2018_33408_60493.jpg

WS slide gate and headwall

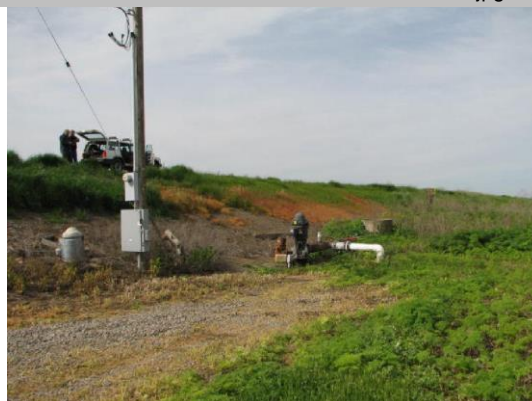
Photo 2 of 3 : UCIP_FA_2018_33408_60495.jpg

LS pump and appurtances

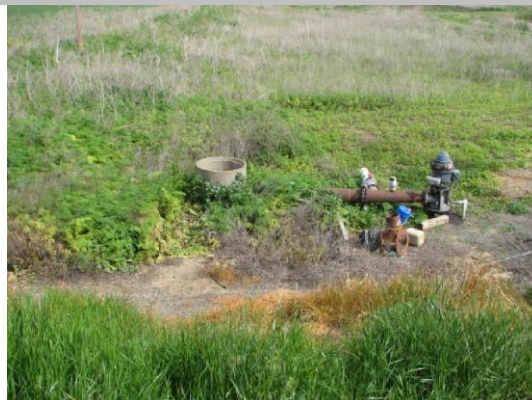
Photo 3 of 3 : UCIP_FA_2018_33408_60494.jpg

LS pump and appurtances

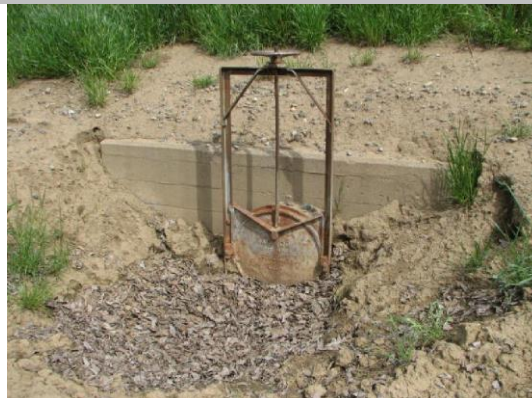
Photo 1 of 2 : UCIP_FA_2018_33394_60458.jpg

Comment Code					
Inspector Comment					
FS_ID:33394 DS_ID:492 EP_NO: 10262 Repair Type: No Action Needed Crossing Status: Found UCIP Comments: FIELD_STRUCT_DESC: 24-inch drainage pipe of unknown material through levee, 13 feet below crown. Slide gate is located on the waterside (WS) end. Concrete headwalls are located on both the waterside (WS) and landside (LS). (24-inch pipe [HLM 2.77] authorized under Automatic Board Order (ABO) issued as Permit No. 10262, 1974 - Wells Fargo Bank, Trustee for S.H. Cowell Foundation) [Additional Reference(s): DWR Levee Log, 1981 and 2005. USACE Sacramento O&M Manual Unit 119, December 1952, (Station XX+XX)] FS Date: 4/10/2014 2:43:44 PM

WS Slide gate

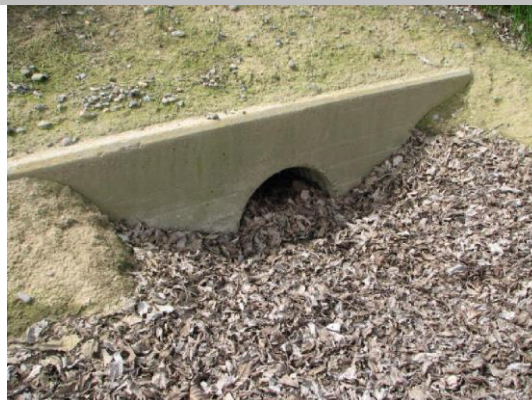
Photo 2 of 2 : UCIP_FA_2018_33394_60457.jpg

LS headwall

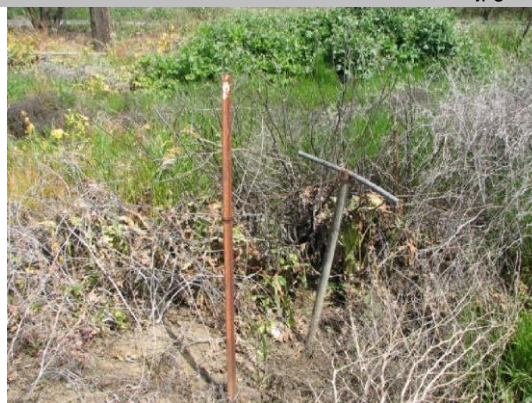
Photo 1 of 3 : UCIP_FA_2018_33381_60439.jpg

Comment Code						
Inspector Comment						
FS_ID:33381						
DS_ID:496						
EP_NO: 10251						
Repair Type: No Action Needed						
Crossing Status: Found						
UCIP Comments:						
FIELD_STRUCT_DESC: 24-inch corrugated metal drainage pipe through levee, 15 feet below the crown. Two metal cutoff walls were installed through the levee. A T-post and T-handle are located on the landside (LS) toe. The outfall structure and flap gate are located on the west side of bridge, waterside (WS). (24-inch pipe [HLM 3.87] authorized under Automatic Board Order (ABO) issued as Permit No. 10251, 1974 - F.M.C. Corp.) [Additional Reference(s): DWR Levee Log, 1981 and 2005. USACE Sacramento O&M Manual Unit 119, December 1952, (Station XX+XX)]						
FS Date: 4/10/2014 2:40:30 PM

WS toe at T handle. No access to pipe.

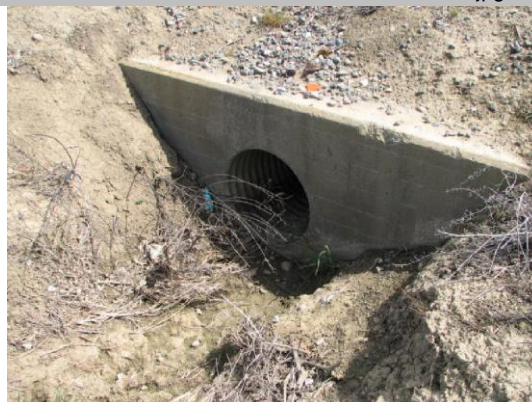
Photo 2 of 3 : UCIP_FA_2018_33381_60441.jpg

LS headwall and pipe

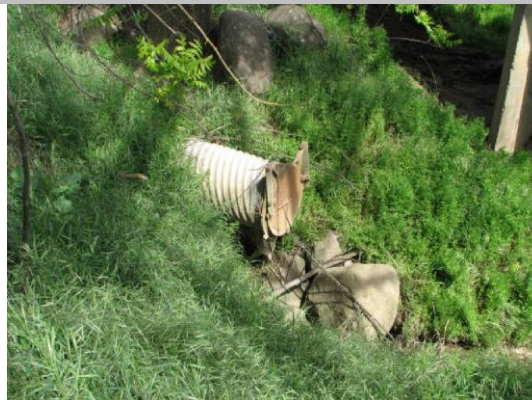
Photo 3 of 3 : UCIP_FA_2018_33381_60440.jpg

Outfall at creek with flap gate.

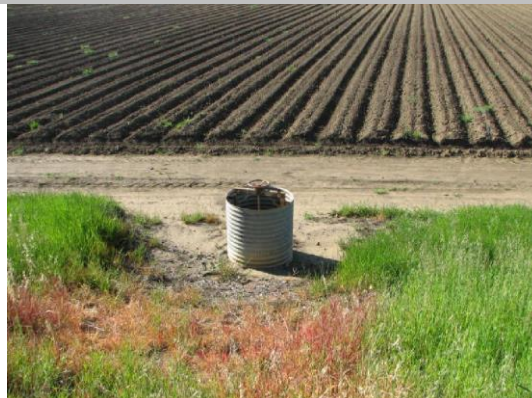
Photo 1 of 1 : UCIP_FA_2018_33379_60436.jpg

Comment Code						
Inspector Comment						
FS_ID:33379						
DS_ID:497						
EP_NO: 10251						
Repair Type: No Action Needed						
Crossing Status: Found						
UCIP Comments:						
FIELD_STRUCT_DESC: PENDING CONSTRUCTION STATUS - 20-inch irrigation welded HDPE pipe sleeved through an existing 24-inch pipe through levee, 16 feet below the crown. Annular space between pipes was filled with grout. 36-inch galvanized corrugated metal pipe (CMP) riser and hinged lid are located on the waterside (WS) slope. (20-inch HDPE installed with a 36-inch galvanized CMP riser and hinged lid, work also included the removal of existing CMP riser authorized under Permit No. 10251-1, 2014 - Harris Moran Seed Company; 24-inch pipe [HLM 4.13] authorized under Automatic Board Order (ABO) issued as Permit No. 10251, 1974 - F.M.C. Corp.; assumed original 24-inch pipe was installed in 12/12/1952 per O&M manual) [Additional Reference(s): DWR Levee Log, 1981 and 2005. USACE Sacramento O&M Manual Unit 119, December 1952, (Station XX+XX)]

Slide gate in 36-inch Standpipe on WS toe.

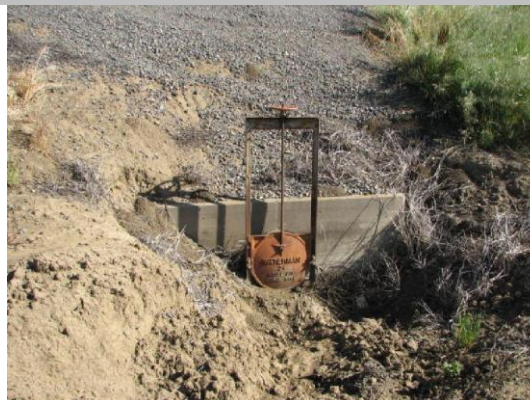
Photo 2 of 3 : UCIP_FA_2018_33371_60416.jpg

WS slide gate

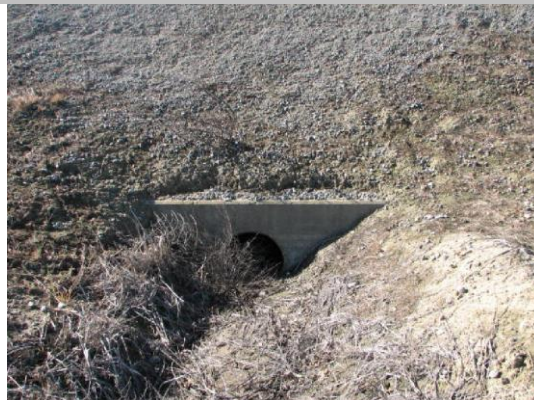
Photo 3 of 3 : UCIP_FA_2018_33371_60417.jpg

LS headwall showing debris

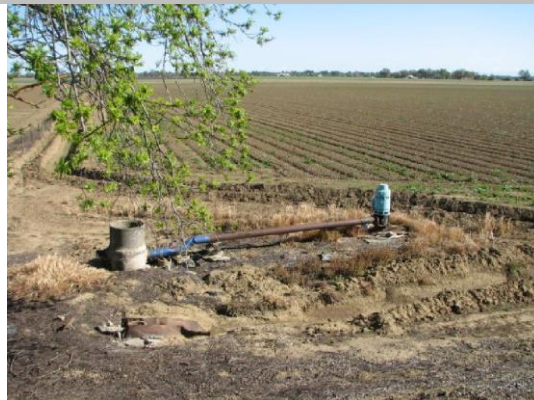
Photo 1 of 2 : UCIP_FA_2018_33370_60415.jpg

LS pump and stand pipe

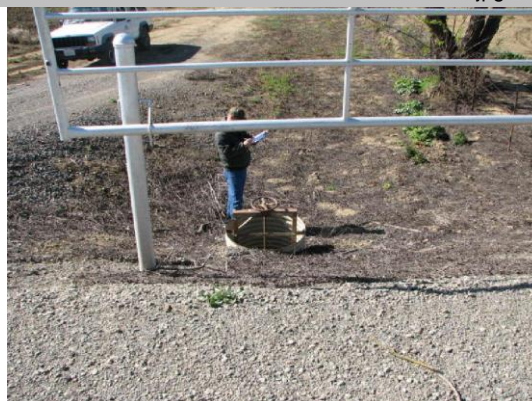
Photo 2 of 2 : UCIP_FA_2018_33370_60414.jpg

WS slide gate in 36-inch cmp standpipe

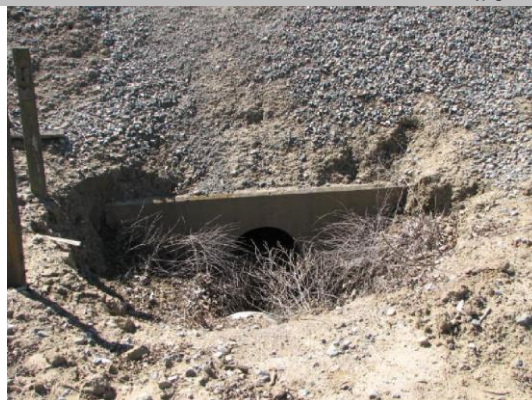
Photo 1 of 2 : UCIP_FA_2018_33368_60410.jpg

LS headwall

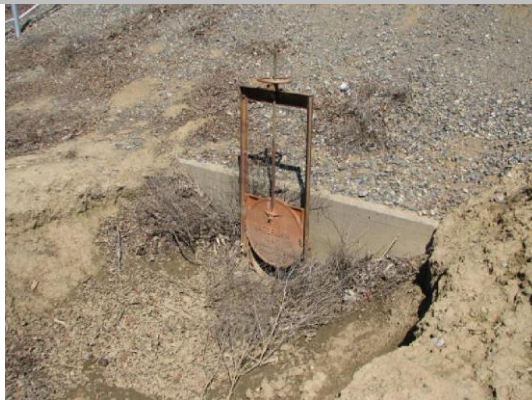
Photo 2 of 2 : UCIP_FA_2018_33368_60409.jpg

Comment Code						
Inspector Comment						
FS_ID:33368						
DS_ID:502						
EP_NO: 10255						
Repair Type: No Action Needed						
Crossing Status: Found						
UCIP Comments:						
FIELD_STRUCT_DESC: 24-inch corrugated metal drainage pipe through the levee, 11 feet below the crown. Slide gate on the waterside (WS) end. Concrete headwall on the landside (LS) end. (24-inch pipe [HLM 5.67] authorized under Automatic Board Order (ABO) issued as Permit No. 10255, 1974 - Owen W. and Ray W. Hamel). [Additional Reference(s): DWR Levee Log, 2005. USACE Sacramento O&M Manual 119, December 1952, (Station 97+00 PCT)].						
FS Date: 4/10/2014 2:35:43 PM

WS slide gate

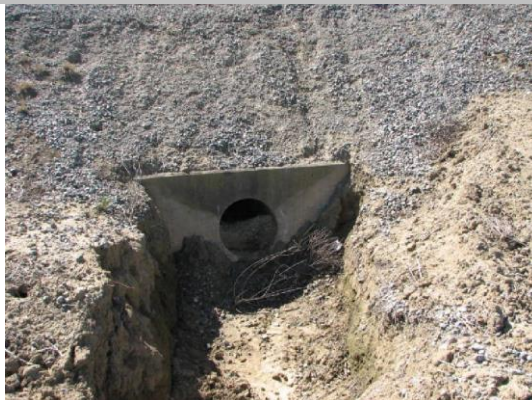
Photo 1 of 2 : UCIP_FA_2018_33364_60401.jpg

Comment Code					
Inspector Comment					
FS_ID:33364					
DS_ID:503					
EP_NO: 10252					
Repair Type: No Action Needed					
Crossing Status: Found					
UCIP Comments: owner of pipe needs to clean out obstruction in pipe.					
FIELD_STRUCT_DESC: 24-inch corrugated metal drainage pipe					
through the levee, 12 feet below the crown. Slide gate on the waterside					
(WS) end. Concrete headwall on the landside (LS) end. (24-inch pipe					
[HLM 5.86] authorized under Automatic Board Order (ABO) issued as					
Permit No. 10252, 1974 - John F. Hamel). [Additional Reference(s):					
DWR Levee Log, 2005. USACE Sacramento O&M Manual 119,					
December 1952, (Station 108+00 PCT)].					
FS Date: 4/10/2014 2:34:15 PM

LS headwall

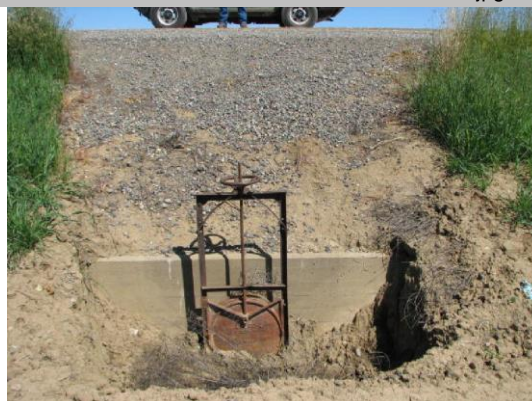
Photo 2 of 2 : UCIP_FA_2018_33364_60400.jpg

WS headwall and slidegate

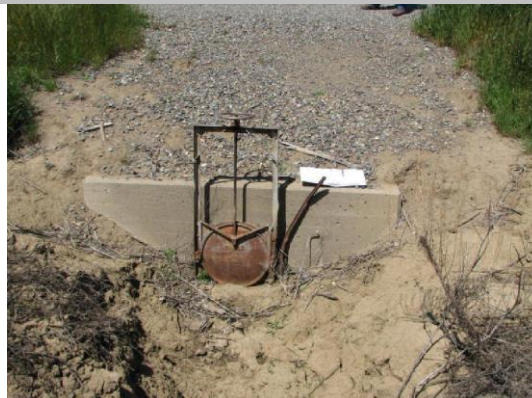
Photo 1 of 2 : UCIP_FA_2018_33349_60372.jpg

WS Slide Gate

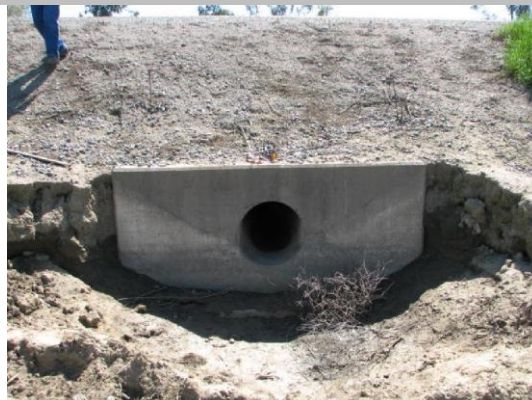
Photo 2 of 2 : UCIP_FA_2018_33349_60371.jpg

LS Headwall

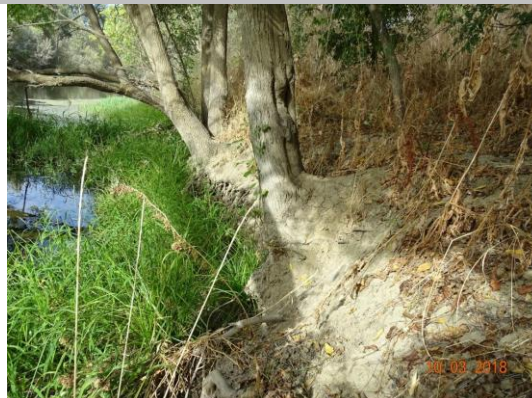
Photo 1 of 1 : FA_2018_ST0007_282_34_20181003_00074.jpg

View looking upstream at erosion at the water side toe. Tree roots are exposed (September 2018).

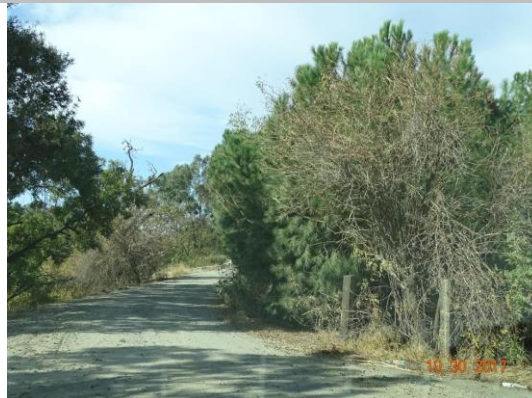
Photo 1 of 1 : FA_2018_ST0007_282_56_20180925_00013.jpg

LM Start	6.89	Rating **	M	Issue No.	56
LM End	6.89	Issue Type +	Ma	Location *	LS
Category	Earthen Levee			GPS Latitude/Longitude	
				Start	End
Item	Trim / Thin Trees			38.517513 °	38.517513 °
				-121.752023 °	-121.752023 °
DWR ID	DWR_ST0007_01_f_2017_56				
Comment Code					
T1 : Trim trees to at least five feet above ground level.					
Inspector Comment

Trees and bushes on landside block visibility and access. Includes elderberries.

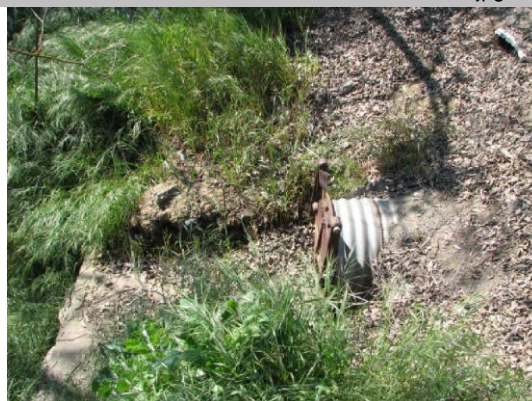
Photo 1 of 3 : UCIP_FA_2018_33343_60357.jpg

Comment Code					
Inspector Comment					
FS_ID:33343 DS_ID:508 EP_NO: 10247 Repair Type: No Action Needed Crossing Status: Found UCIP Comments: FIELD_STRUCT_DESC: 24-inch drainage pipe of an unknown material through the levee, 11 feet below the crown. Flap gate on the waterside (WS) end. Concrete headwall on the landside (LS) end. Concrete Apron on the WS. (24-inch pipe [HLM 7.09] authorized under Automatic Board Order (ABO) issued as Permit No. 10247, 1974 - University of California, Office of the Regents). [Additional Reference(s): DWR Levee Log, 2005. USACE Sacramento O&M Manual 119, December 1952, (Station 172+00 PCT)]. FS Date: 4/10/2014 2:27:50 PM

WS flap gate

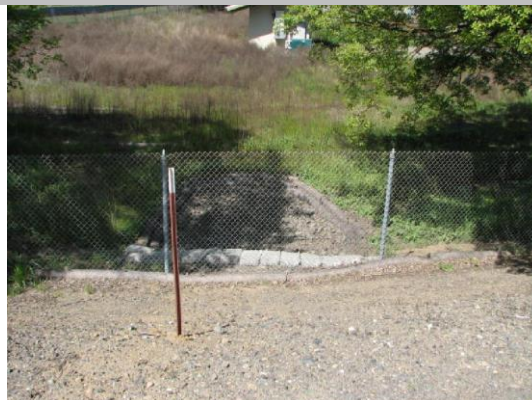
Photo 2 of 3 : UCIP_FA_2018_33343_60359.jpg

LS headwall

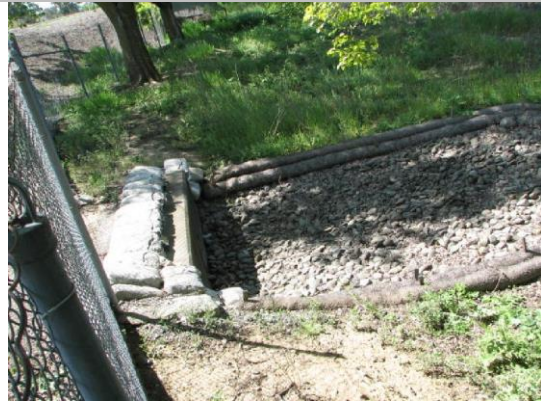
Photo 3 of 3 : UCIP_FA_2018_33343_60358.jpg

LS headwall

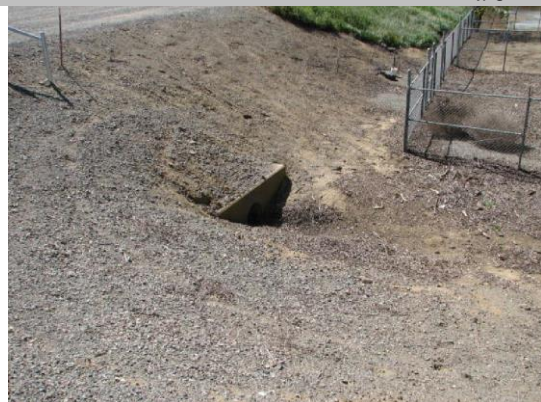
Photo 1 of 2 : UCIP_FA_2018_42952_60353.jpg

Comment Code					
Inspector Comment					
FS_ID:42952 DS_ID:512 EP_NO: 10247 Repair Type: No Action Needed Crossing Status: Found UCIP Comments: Debris removed from outlet FIELD_STRUCT_DESC: 24-inch drainage pipe of an unknown material through the levee, 12 feet below the crown. Flap gate on the waterside (WS) end. Concrete headwall on the landside (LS) end. (24-inch [HLM 7.36] authorized under Automatic Board Order (ABO) issued as Permit No. 10247, 1974 - University of California, Office of the Regents). [Additional Reference(s): DWR Levee Log, 2005. USACE Sacramento O&M Manual 119, December 1952, (Station 183+97 PCT)]. FS Date: 4/10/2014 2:27:00 PM

LS Headwall

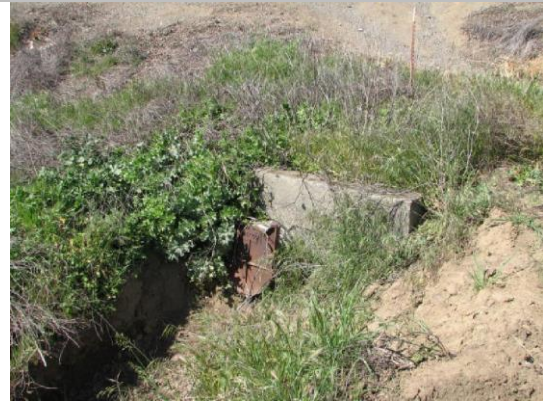
Photo 2 of 2 : UCIP_FA_2018_42952_60352.jpg

WS Flapgate

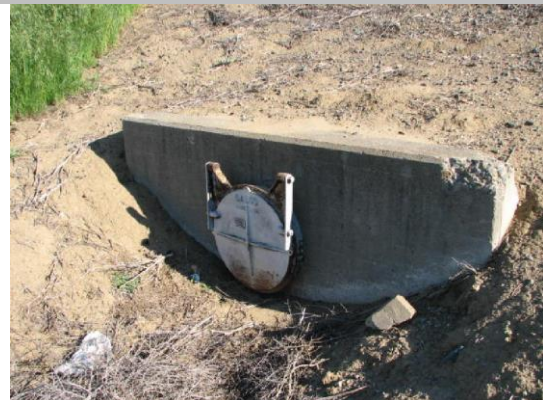
Photo 1 of 2 : UCIP_FA_2018_41353_60345.jpg

WS Flap Gate and headwall.

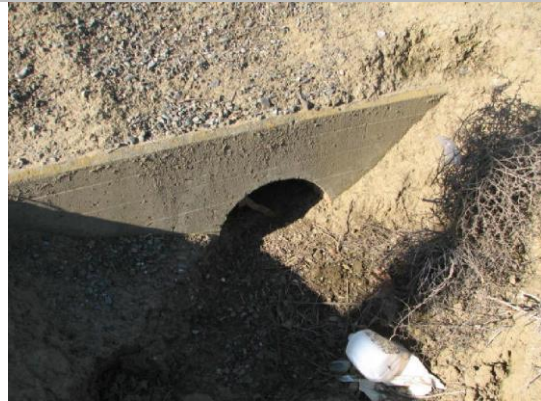
Photo 2 of 2 : UCIP_FA_2018_41353_60344.jpg

Comment Code						
Inspector Comment						
FS_ID:41353 DS_ID:516 EP_NO: 10260 Repair Type: Non-Urgent Crossing Status: Found UCIP Comments: Pipe is partially obstructed with sedimentation. Owner of pipe may have to clean sediment FIELD_STRUCT_DESC: 24-inch corrugated metal drainage pipe through the levee, 12 feet below the crown. Flap gate on the waterside (WS) end. (24-inch pipe [HLM 7.52] authorized under Automatic Board Order (ABO) issued as Permit No. 10260, 1974 - Southern Pacific Transportation Company). [Additional Reference(s): DWR Levee Log, 2005. USACE Sacramento O&M Manual 119, December 1952, (Station 193+20 PCT)]. FS Date: 4/10/2014 2:25:00 PM

LS headwall showing pipe partially blocked with soil.

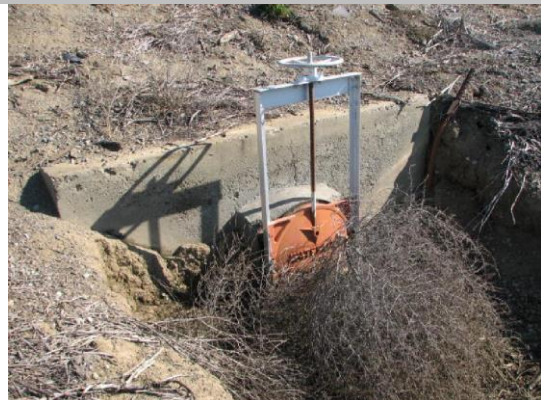
Photo 1 of 2 : UCIP_FA_2018_33333_60342.jpg

Comment Code					
Inspector Comment					
FS_ID:33333					
DS_ID:518					
EP_NO: 10247					
Repair Type: No Action Needed					
Crossing Status: Found					
UCIP Comments: Fence blocking inlet. Owner of fence needs to move fence away from inlet.					
FIELD_STRUCT_DESC: 24-inch corrugated metal drainage pipe through the levee, 12 feet below the crown. Slide gate on the waterside (WS) slope, and headwalls on both sides. (24-inch pipe [HLM 7.75] authorized under Automatic Board Order (ABO) issued as Permit No. 10247, 1974 - University of California, Office of the Regents). [Additional Reference(s): DWR Levee Log, 2005. USACE Sacramento O&M Manual 119, December 1952, (Station 204+00 PCT)].					
FS Date: 4/10/2014 2:24:52 PM

WS headwall and slide gate

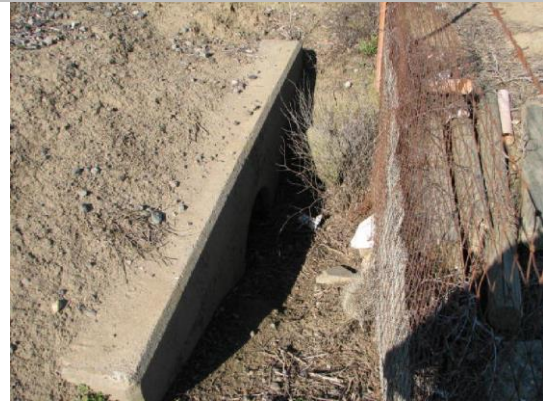
Photo 2 of 2 : UCIP_FA_2018_33333_60341.jpg

Comment Code						
Inspector Comment						
FS_ID:33333 DS_ID:518 EP_NO: 10247 Repair Type: No Action Needed Crossing Status: Found UCIP Comments: Fence blocking inlet. Owner of fence needs to move fence away from inlet. FIELD_STRUCT_DESC: 24-inch corrugated metal drainage pipe through the levee, 12 feet below the crown. Slide gate on the waterside (WS) slope, and headwalls on both sides. (24-inch pipe [HLM 7.75] authorized under Automatic Board Order (ABO) issued as Permit No. 10247, 1974 - University of California, Office of the Regents). [Additional Reference(s): DWR Levee Log, 2005. USACE Sacramento O&M Manual 119, December 1952, (Station 204+00 PCT)]. FS Date: 4/10/2014 2:24:52 PM

LS headwall showing fence and soil buildup.

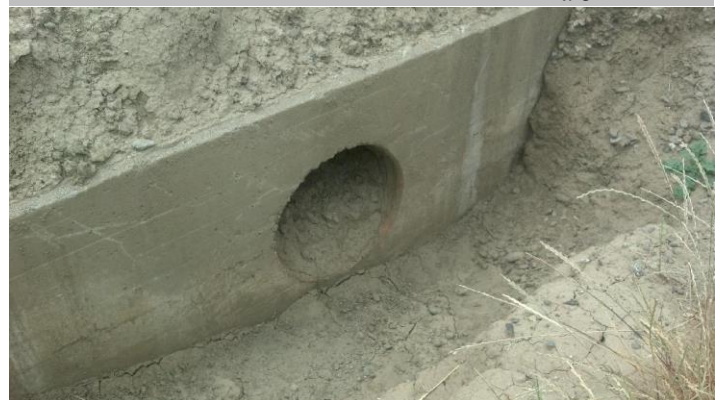
Photo 1 of 3 : UCIP_FA_2018_33328_60329.jpg

Comment Code					
Inspector Comment					
FS_ID:33328 DS_ID:520 EP_NO: 10247 Repair Type: No Action Needed Crossing Status: Found UCIP Comments: Cleaned inlet and outlets. Owner of pipe may need to clean pipe FIELD_STRUCT_DESC: 24-inch corrugated metal drainage pipe through the levee, 8 feet below the crown. Slide gate on the waterside (WS) end. (24-inch pipe [HLM 8.45] authorized under Automatic Board Order (ABO) issued as Permit No. 10247, 1974 - University of California, Office of the Regents). [Additional Reference(s): DWR Levee Log, 2005. USACE Sacramento O&M Manual 119, December 1952, (Station 241+50 PCT)]. FS Date: 4/10/2014 2:23:46 PM

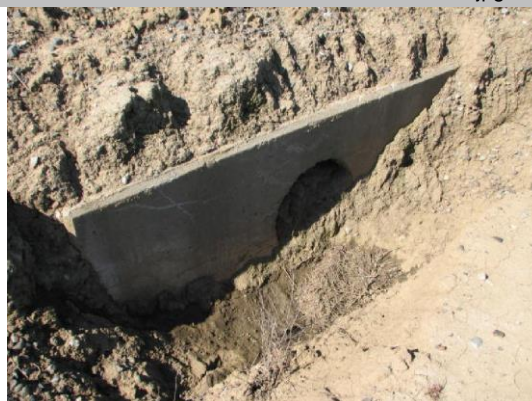
Photo 2 of 3 : UCIP_FA_2018_33328_60327.jpg

Comment Code						
Inspector Comment						
FS_ID:33328 DS_ID:520 EP_NO: 10247 Repair Type: No Action Needed Crossing Status: Found UCIP Comments: Cleaned inlet and outlets. Owner of pipe may need to clean pipe FIELD_STRUCT_DESC: 24-inch corrugated metal drainage pipe through the levee, 8 feet below the crown. Slide gate on the waterside (WS) end. (24-inch pipe [HLM 8.45] authorized under Automatic Board Order (ABO) issued as Permit No. 10247, 1974 - University of California, Office of the Regents). [Additional Reference(s): DWR Levee Log, 2005. USACE Sacramento O&M Manual 119, December 1952, (Station 241+50 PCT)]. FS Date: 4/10/2014 2:23:46 PM

LS headwall showing pipe plugged with soil

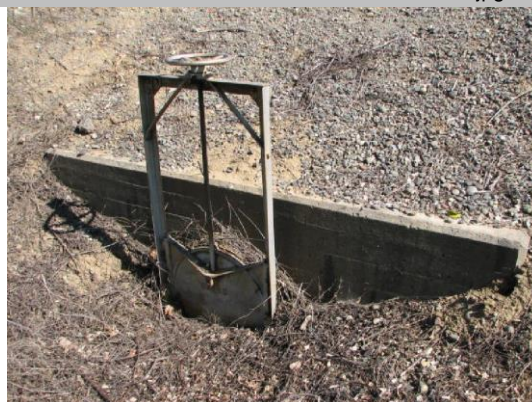
Photo 3 of 3 : UCIP_FA_2018_33328_60328.jpg

WS slide gate showing some blockage with soil.

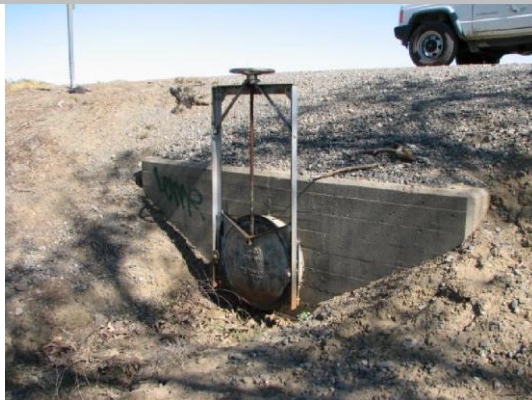
Photo 1 of 2 : UCIP_FA_2018_33327_60326.jpg

WS headwall and slidegate

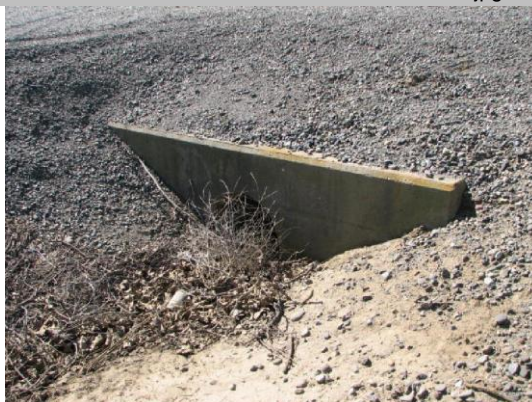
Photo 2 of 2 : UCIP_FA_2018_33327_60325.jpg

LS headwall showing partial blockage

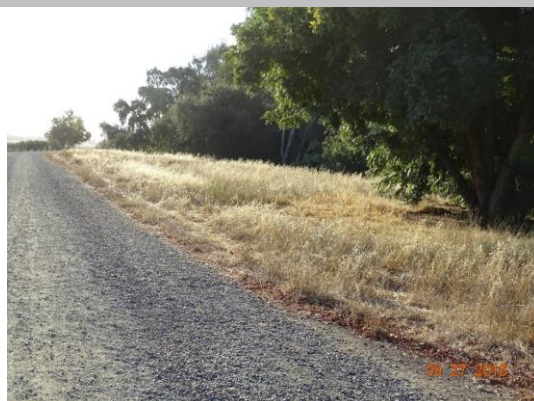
Photo 1 of 1 : FA_2018_ST0007_282_29_20180928_00073.jpg

View looking downstream at thick vegetation up to the crown (September 2018).

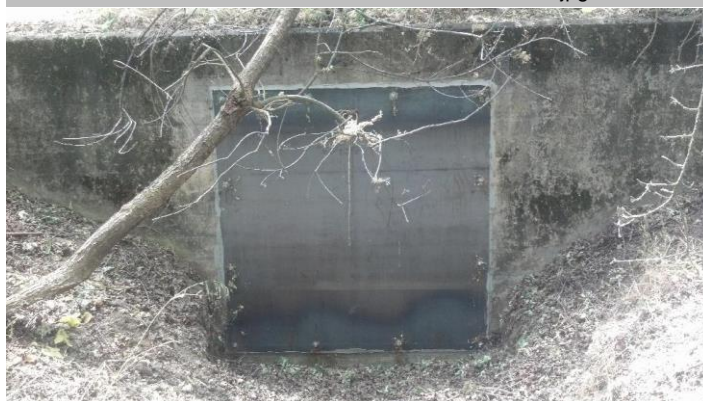
Photo 1 of 3 : UCIP_FA_2018_41129_60301.jpg

Steel plate installed over pipe off LS toe.

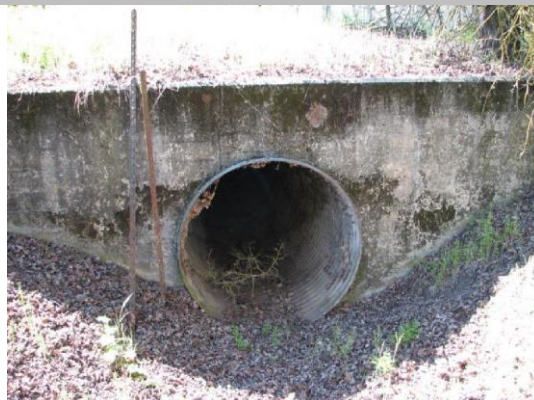
Photo 2 of 3 : UCIP_FA_2018_41129_60299.jpg

LS headwall and pipe before steel plate was installed over pipe to abandon it.

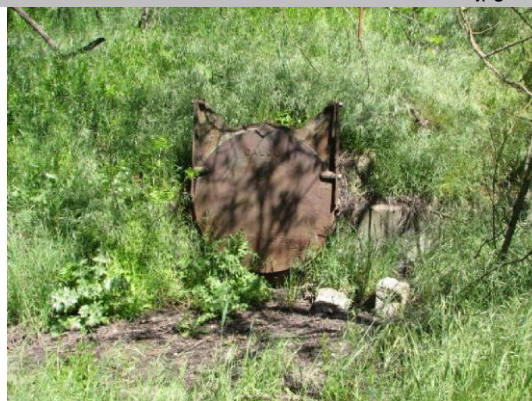
Photo 3 of 3 : UCIP_FA_2018_41129_60300.jpg

WS flap gate

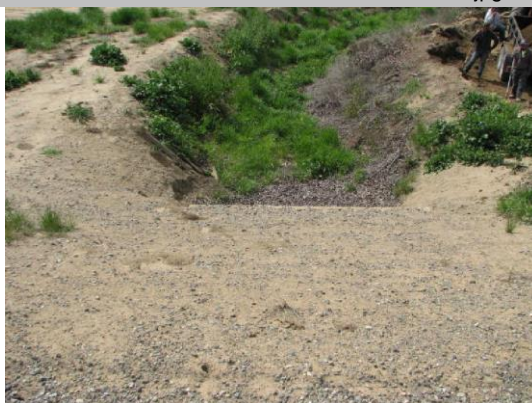
Photo 1 of 3 : UCIP_FA_2018_33407_60489.jpg

L/S inlet

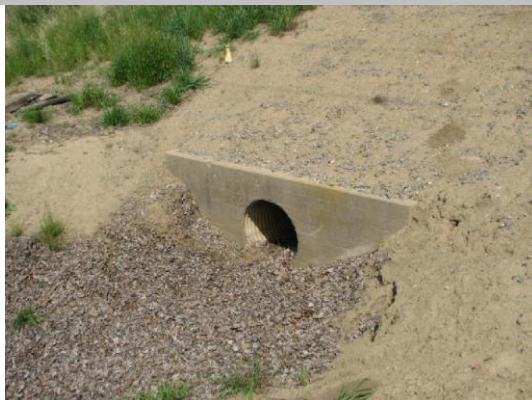
Photo 2 of 3 : UCIP_FA_2018_33407_60492.jpg

L/S headwall

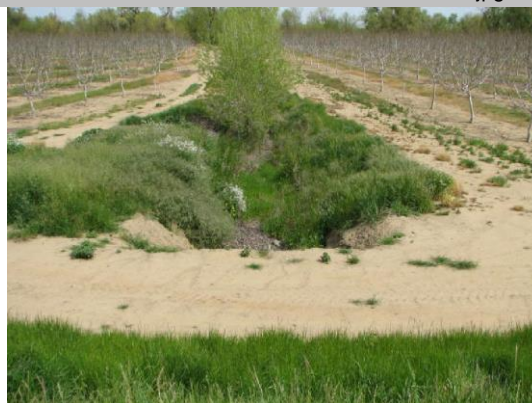
Photo 3 of 3 : UCIP_FA_2018_33407_60491.jpg

W/S Channel

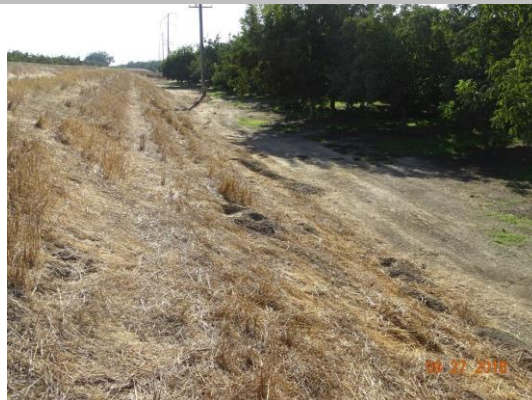
Photo 1 of 3 : FA_2018_ST0007_283_32_20180928_00062.jpg

View looking downstream at multiple animal holes on the levee slope (September 2018).

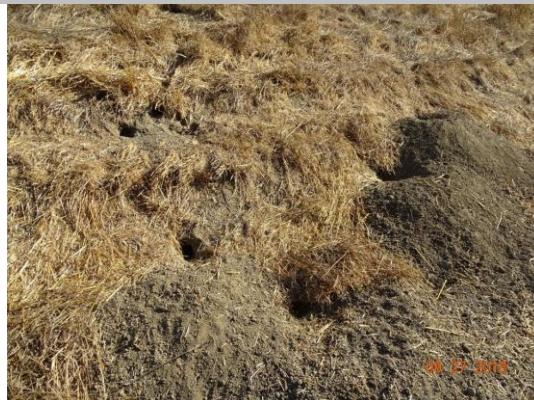
Photo 2 of 3 : FA_2018_ST0007_283_32_20180928_00061.jpg

View of multiple animal holes on the levee slope with fresh dirt in front of the holes (September 2018).

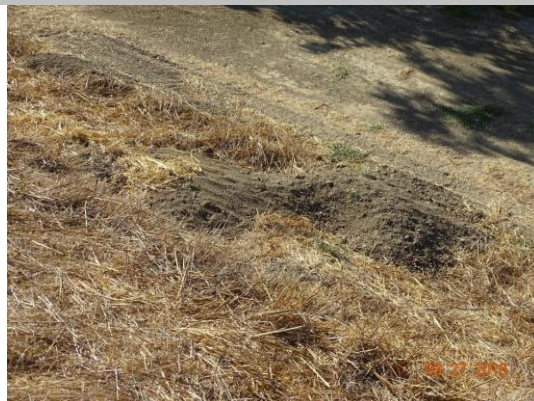
Photo 3 of 3 : FA_2018_ST0007_283_32_20180928_00063.jpg

View looking down slope at one of the animal holes on the levee slope with fresh dirt in front of the hole (September 2018).

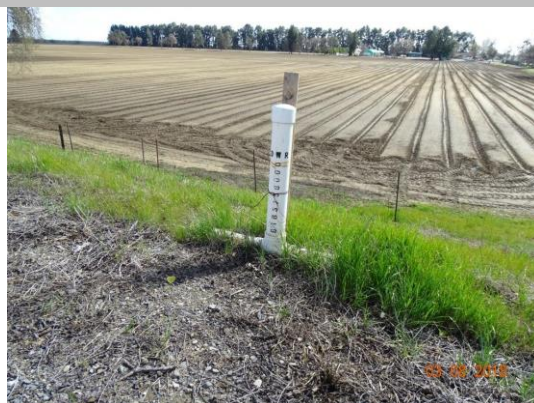
Photo 1 of 1 : FA_2018_ST0007_283_9_20180924_00002.jpg

Rodent bait station at LM 2.09.

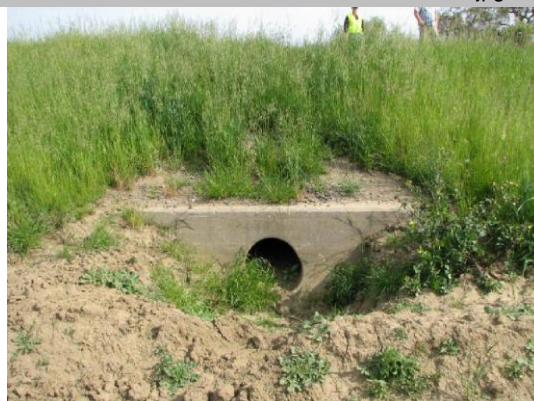
Photo 1 of 2 : UCIP_FA_2018_33395_60460.jpg

LS headwall

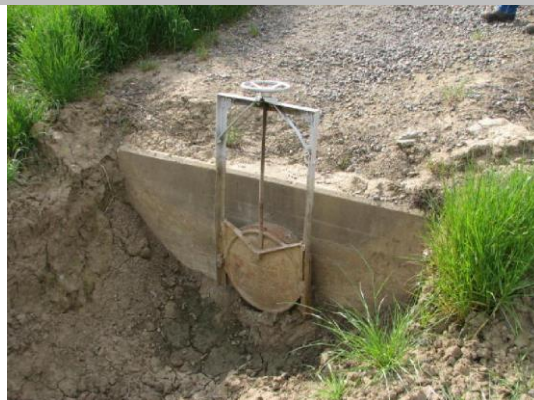
Photo 2 of 2 : UCIP_FA_2018_33395_60459.jpg

WS headwall and slidegate

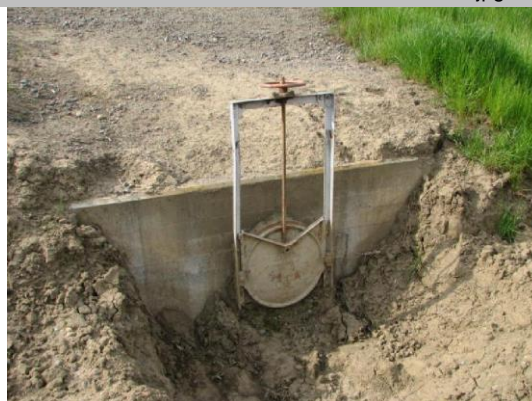
Photo 1 of 2 : UCIP_FA_2018_33393_60456.jpg

WS headwall and slide gate

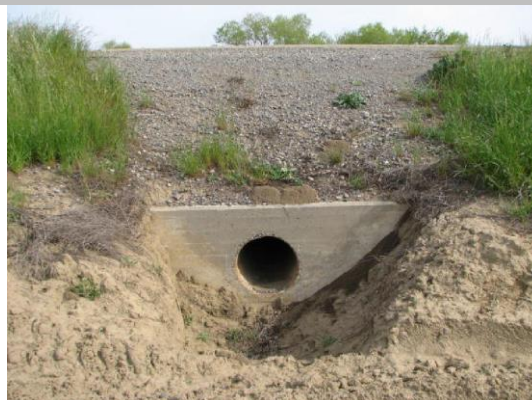
Photo 2 of 2 : UCIP_FA_2018_33393_60455.jpg

LS headwall and pipe

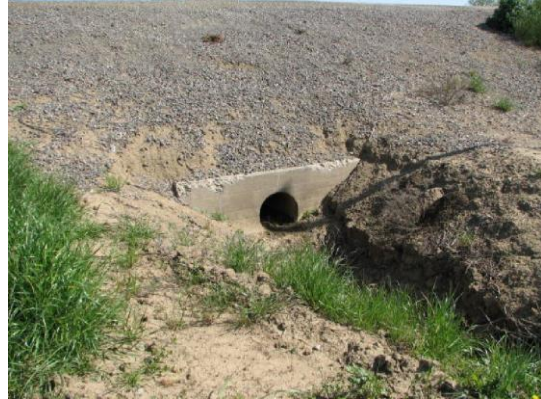
Photo 1 of 2 : UCIP_FA_2018_33378_60435.jpg

LS headwall

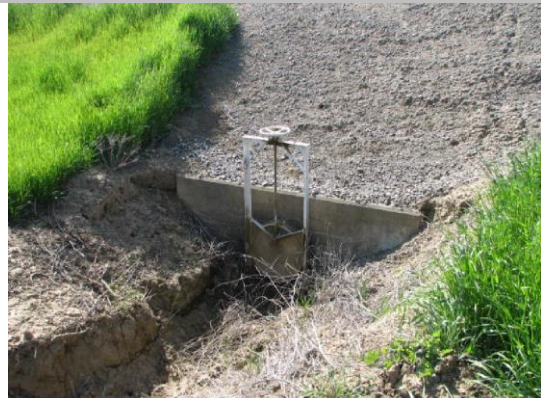
Photo 2 of 2 : UCIP_FA_2018_33378_60434.jpg

WS slide gate and headwall

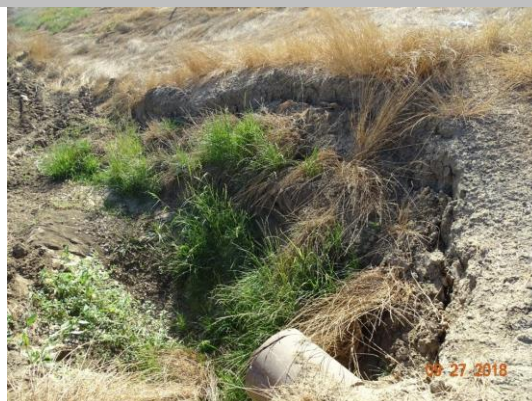
Photo 1 of 1 : FA_2018_ST0007_283_33_20180928_00064.jpg

View of erosion on the levee slope appears to be due to water from the pipe and trench (September 2018).

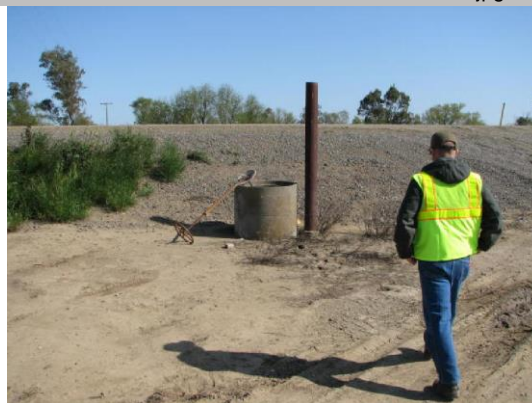
Photo 1 of 3 : UCIP_FA_2018_33375_60427.jpg

LS 36-inch standpipe

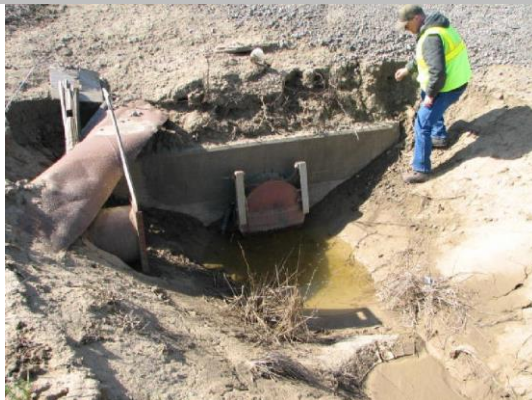
Photo 2 of 3 : UCIP_FA_2018_33375_60429.jpg

WS headwall and flapgate.

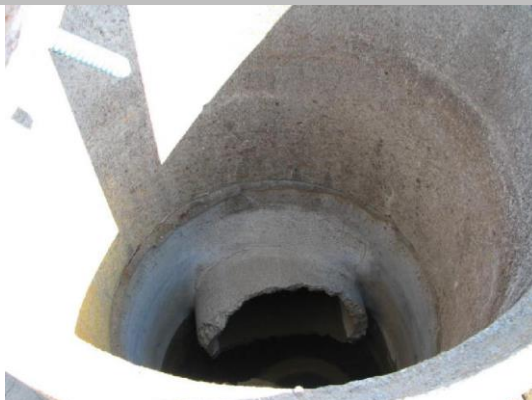
Photo 3 of 3 : UCIP_FA_2018_33375_60428.jpg

LS looking down standpipe at CC pipe

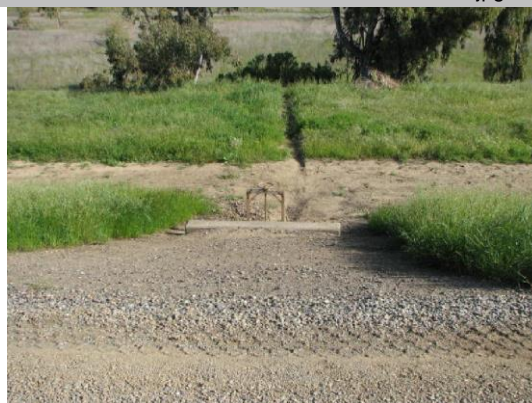
Photo 1 of 3 : UCIP_FA_2018_33369_60411.jpg

W/S

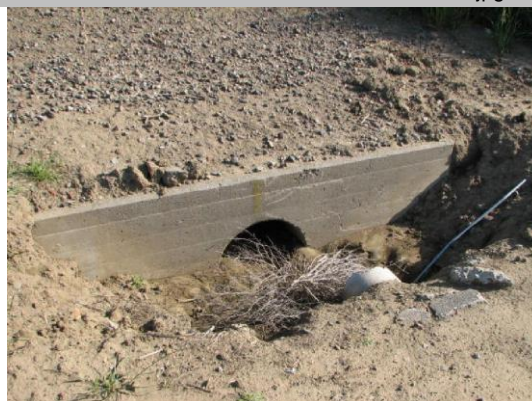
Photo 2 of 3 : UCIP_FA_2018_33369_60413.jpg

L/S Clogged

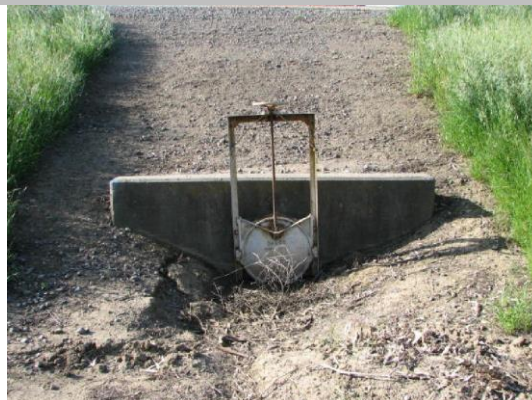
Photo 3 of 3 : UCIP_FA_2018_33369_60412.jpg

W/S positive closure device

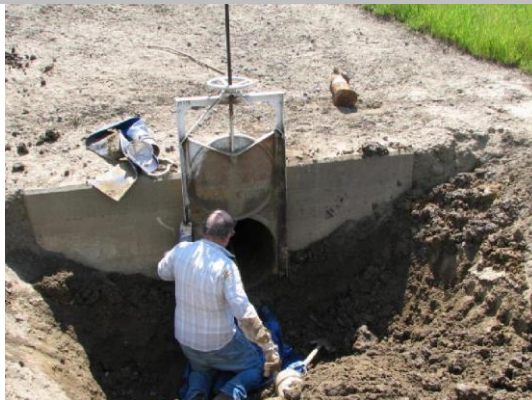
Photo 1 of 2 : UCIP_FA_2018_33363_60399.jpg

WS slide gate and headwall. 6-inch irrigation pipe just inside 24-inch pipe.

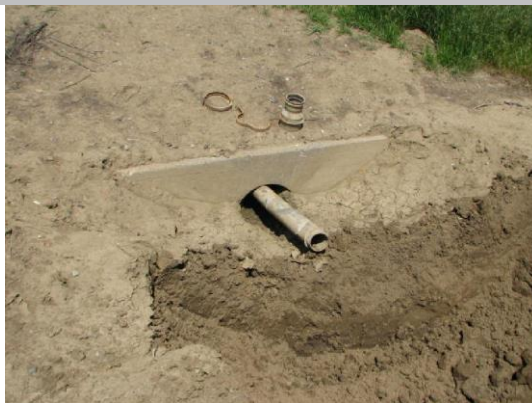
Photo 2 of 2 : UCIP_FA_2018_33363_60398.jpg

LS headwall showing sedimentation and 6-inch pipe sleeved through 24-inch pipe.

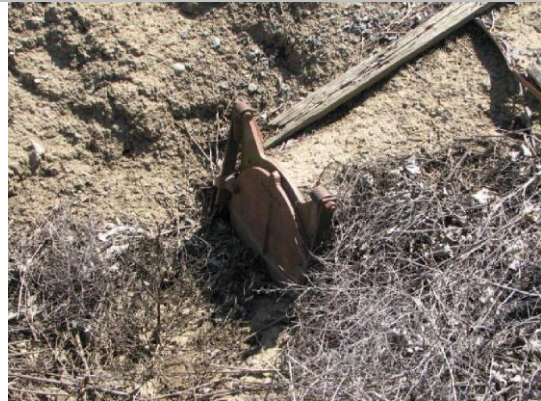
Photo 1 of 2 : UCIP_FA_2018_42953_60397.jpg

WS Flapgate blocked by sedimentation

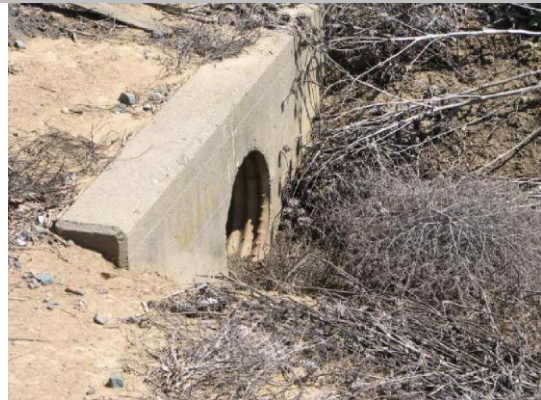
Photo 2 of 2 : UCIP_FA_2018_42953_60396.jpg

LS headwall

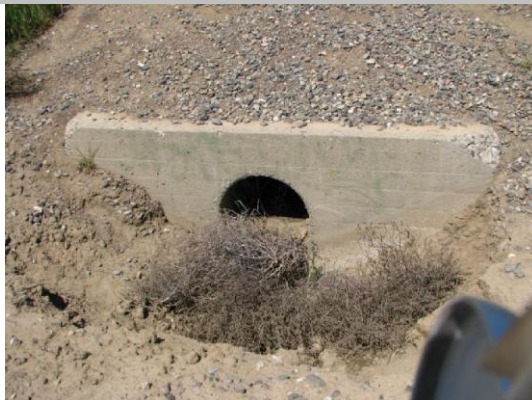
Photo 1 of 2 : UCIP_FA_2018_33353_60380.jpg

LS headwall and pipe showing sediment buildup.

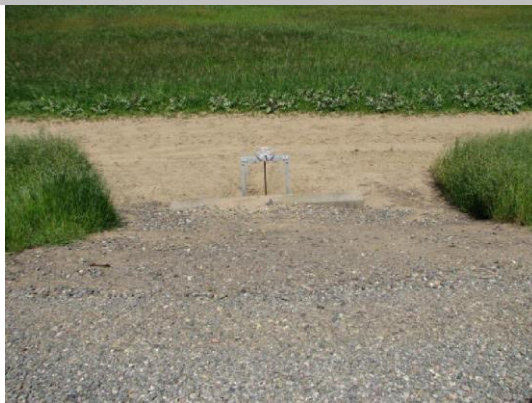
Photo 2 of 2 : UCIP_FA_2018_33353_60379.jpg

WS slide gate

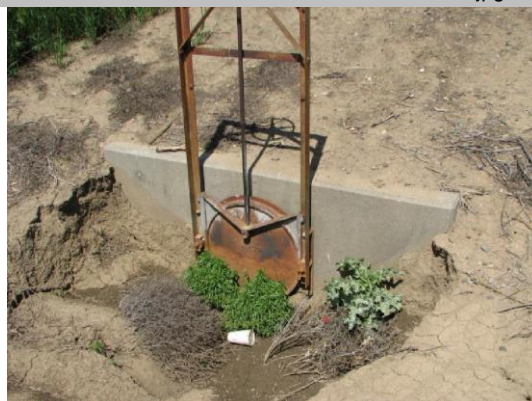
Photo 1 of 2 : UCIP_FA_2018_42959_60374.jpg

LS slide gate

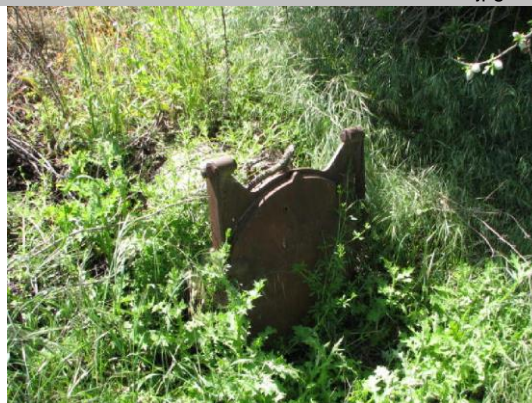
Photo 2 of 2 : UCIP_FA_2018_42959_60373.jpg

WS flap gate

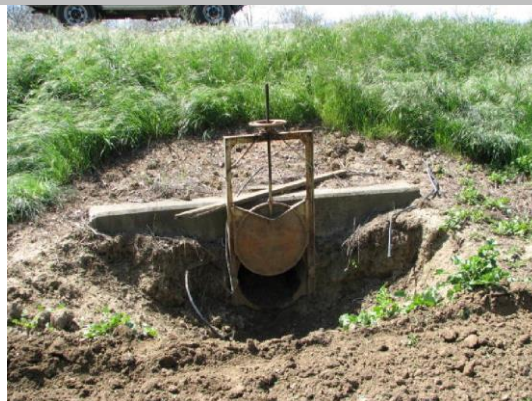
Photo 1 of 2 : UCIP_FA_2018_33346_60364.jpg

WS slide gate showing soil plug

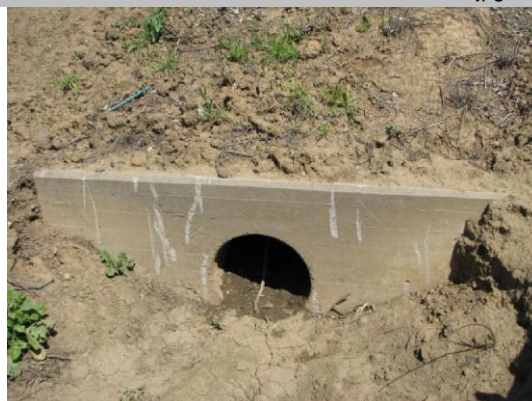
Photo 2 of 2 : UCIP_FA_2018_33346_60363.jpg

LS headwall showing soil plug

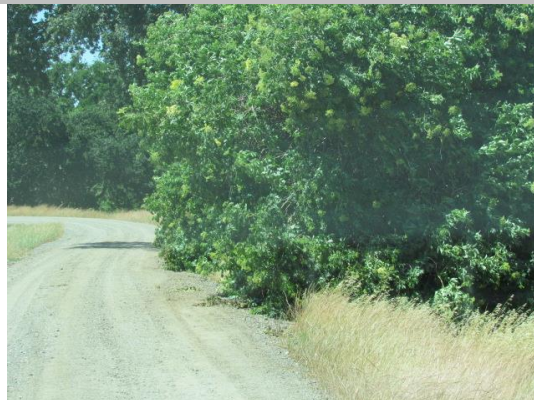
Photo 1 of 1 : FA_2018_ST0007_283_47_20180924_00013.jpg

Elderberry bushes blocking view of waterside shoulder at this location.
